**IN THE COURT OF APPEAL OF THE REPUBLIC OF SINGAPORE**

**[2023] SGCA 20**

Court of Appeal / Civil Appeal No 45 of 2022

## JUDGMENT

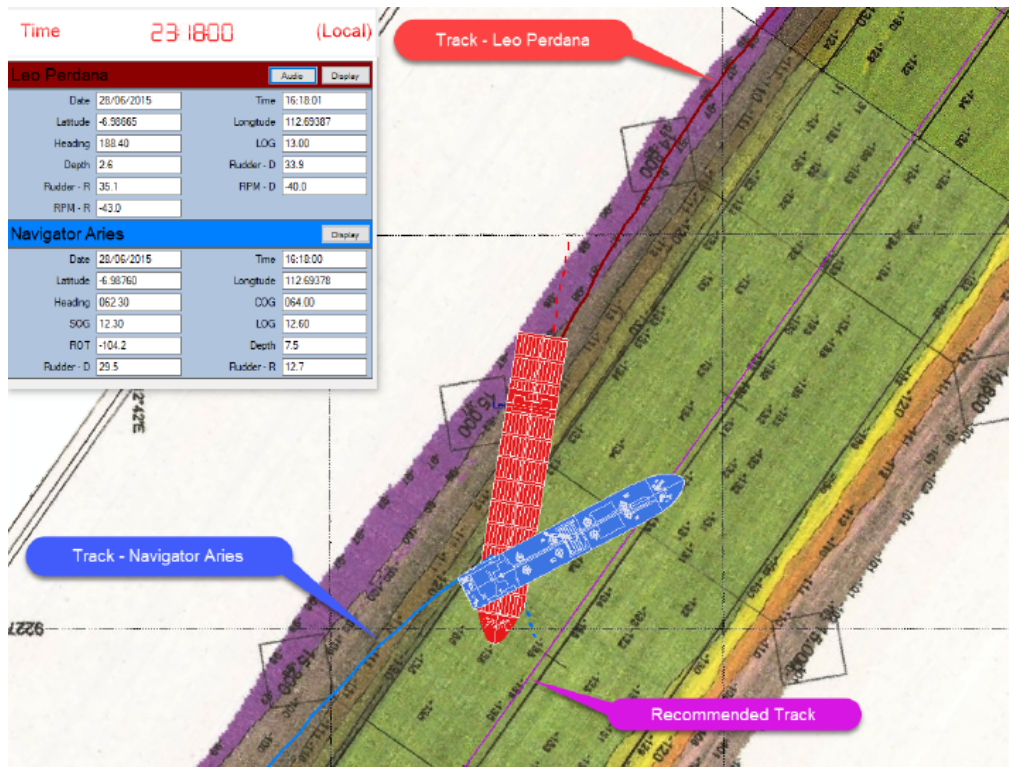
36 The manoeuvres undertaken by both vessels ultimately failed to prevent the collision from occurring. By 23:17:30 hours, the vessels were only about 0.1nm apart and closing at a combined speed of about 28 knots. The vessels’ initially uneventful voyages underwent a sea change with the port sheer, with the *LP*’s heading changing from 222.9° at the time the sheer commenced at 23:16:46 hours, to 198.6° at the time of the collision at 23:17:51 hours (*ie*, she went to port by 24.3°). At 23:17:51 hours, the *LP*’s bow struck the *NA*’s port side at an acute angle. The angle of the blow is illustrated in the AIS plot below:

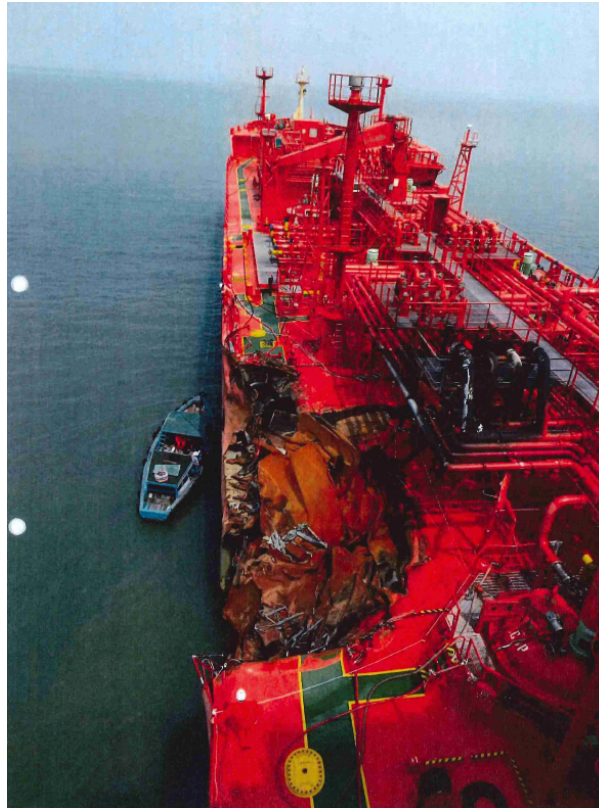
37 The actual impact of the blow is also captured in this photograph of the *NA* taken post-collision:

38 Seconds after the collision occurred, the *NA* suffered a cargo fire and began drifting in a northerly direction. The *LP* moved astern to pull away, and the vessels separated by around 23:19 hours. The *LP* then proceeded on a northerly course that brought her beyond the western edge of the Dredged Channel.

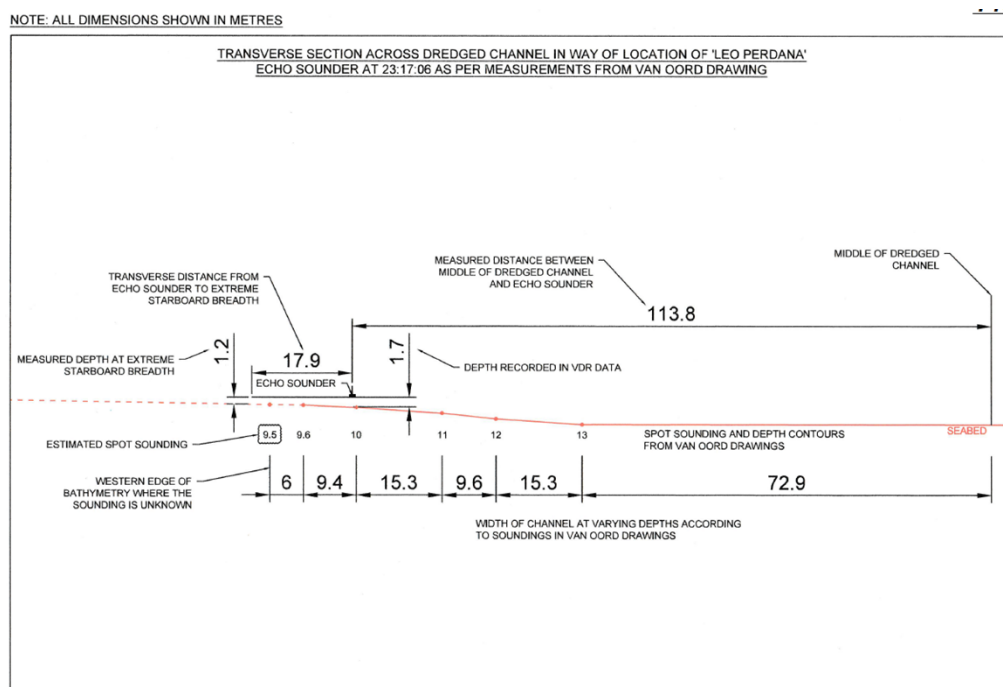
on her echo transducer data. The parties’ experts submitted the following diagram, showing a UKC of 1.2m on the *LP*’s starboard side and 1.7m UKC on her port side. We accept that this differential provides the conditions for bow cushion effect to arise.

To be clear, the port sheer occurred at 23:16:46 hours. The reason the above diagram refers to measurements taken at 23:17:06 hours is that there was a lag of about 20 seconds between the time the *LP*’s bow would have crossed a given spot on the seabed, and the time her echo transducer would have crossed that same spot. This is because her echo transducer was some 147m aft of the forward perpendicular. A 20 second adjustment was thus applied to estimate the *LP*’s UKC at 23:16:46 hours.

theory that the *LP* experienced bow cushion effect. On the evidence, we are satisfied that the immediate cause of the collision was the *LP*’s port sheer, the physical cause of which was the bow cushion effect. That said, as highlighted at [64] above, the speed of the vessel has a direct and material bearing on the risk of bow cushion effect. The significance of this is elaborated on at [200] and [214] below.

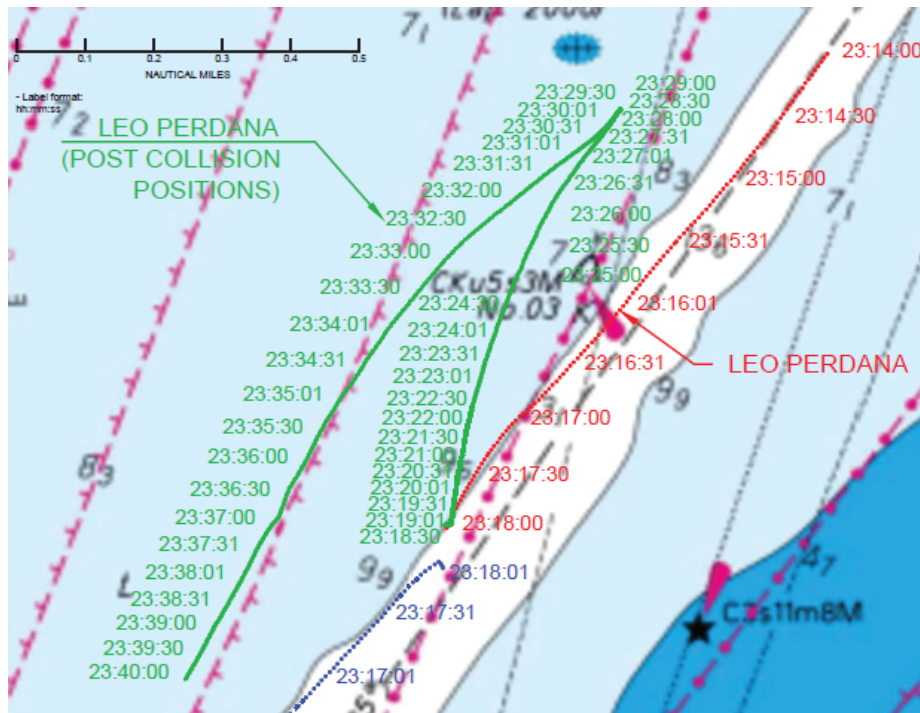
139 We address each observation in turn, starting with the *LP*’s post-collision track. Using the *LP*’s AIS positions, the appellant’s experts had mapped out her post-collision track as follows (in green):

We mention for completeness that this map does not reflect the Strait’s bathymetry *post*-dredging. It is based on BA Chart 975, which was published in 2012 prior to the dredging activity in 2015. However, nothing really turns on this observation in our analysis of Rule 9, although we will return to this in relation to Rule 2 (see [158] below).

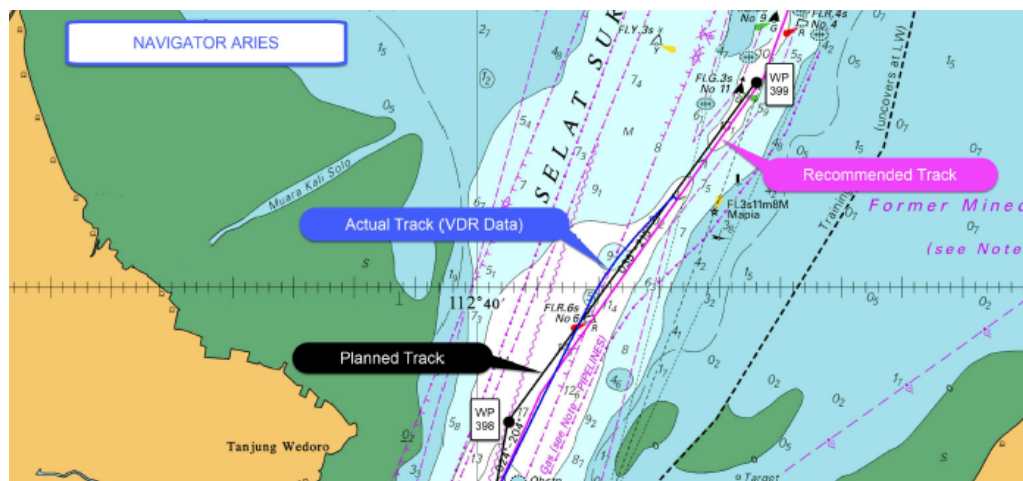
177 At about 23:10 hours, the *NA* reached the charted point where the axis of the Recommended Track changed from 024° to 035° (see the diagram at [178] below). But the *NA* did not adjust her course to starboard, and kept her COG around 026° – some 9° port off the Recommended Track. She remained to the west of the Recommended Track up to the time of collision. Comparing her heading and COG, it appeared that she was unable to overcome a drift angle of some 6° to port due to the prevailing northerly current.

178 From the following chart prepared by Capt Hart, it can be seen that the *NA*’s actual track (in blue) cut across that of the Recommended Track (in pink) as she travelled northwards, with her actual track remaining to the west of the Recommended Track up to the point of collision (where the blue line terminates):

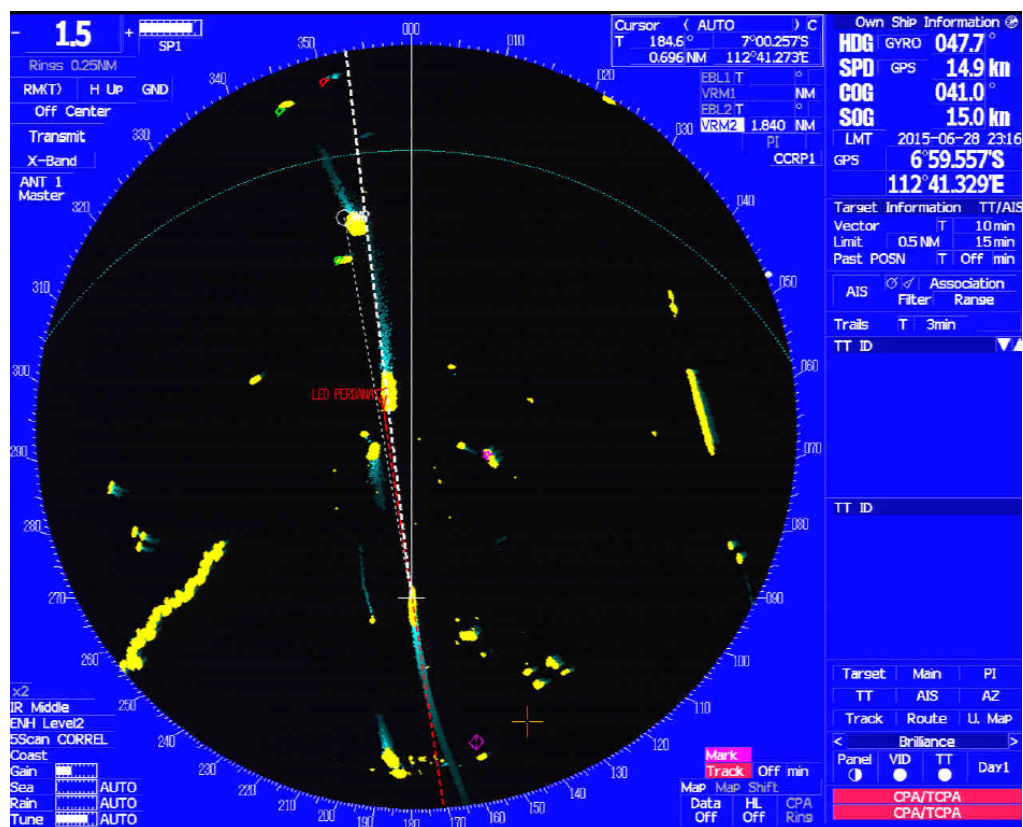
196 From their courses, the vessels also appeared to be shaping to complete the red-to-red passing. As described above at [101], the vessels’ red sidelights had opened and green sidelights had closed by 23:15 to 23:16 hours, indicating that each vessel was off the other’s port bow. The point is made starker when one compares the following radar screengrabs from the *NA*’s X-Band radar (which is set to head-up mode with relative motion, and a 1.5nm range). The first screengrab, taken at 23:16:14 hours, shows the *LP*’s radar echo lying on the *NA*’s COG line (*ie*, the white dashed line extending from the *NA*).

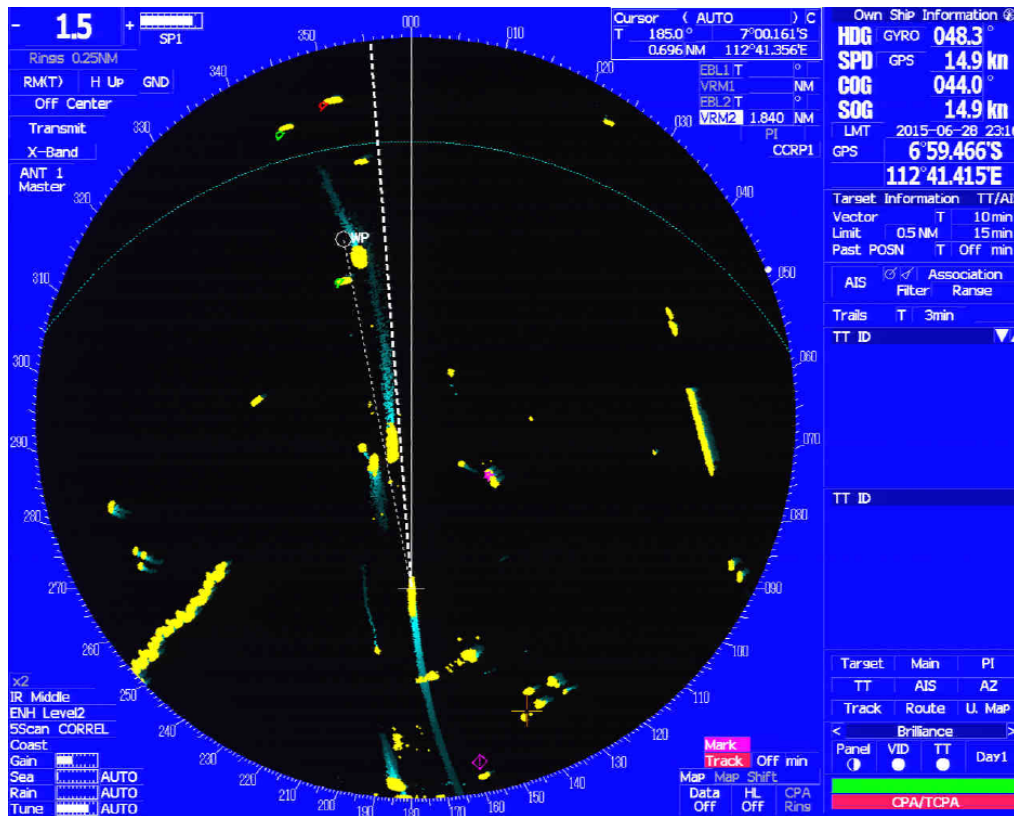
197 The screenshot taken 30 seconds later at 23:16:44 hours (reproduced below) shows the *LP*'s radar echo now lying *port* of the *NA*'s COG line, as vessels shaped to pass port-to-port. This was just before the port sheer commenced at 23:16:46 hours.
