Airtrust (Hong Kong) Ltd v PH Hydraulics & Engineering Pte Ltd
[2015] SGHC 307

Case Number : Suit No 219 of 2013
Decision Date : 30 November 2015
Tribunal/Court : High Court
Coram : Chan Seng Onn J
Counsel Name(s) : Tan Chuan Thye SC, Avinash Pradhan, Alyssa Leong and Arthi Anbalagan (Rajah & Tann Singapore LLP) for the plaintiff; Daniel John and Kevin Cheng (Goodwins Law Corporation) for the defendant.
Parties : AIRTRUST (HONG KONG) LTD — PPH HYDRAULICS & EENGINEERING PTE LTD

Commercial Transactions – Sale of Equipment – Breach of Contract

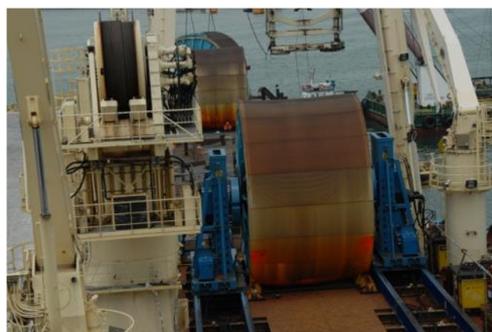
2 In 2007, the Plaintiff purchased a 300 tons reel drive unit (“RDU”) from the Defendant. Attached below is a photograph of the RDU that was fabricated by the Defendant. The photograph shows a 300 tons reel (brown in colour) sandwiched between the two towers of the RDU (blue in colour) mounted on skids (blue in colour) on the deck at the aft of the ship, the “Maersk Responder”.

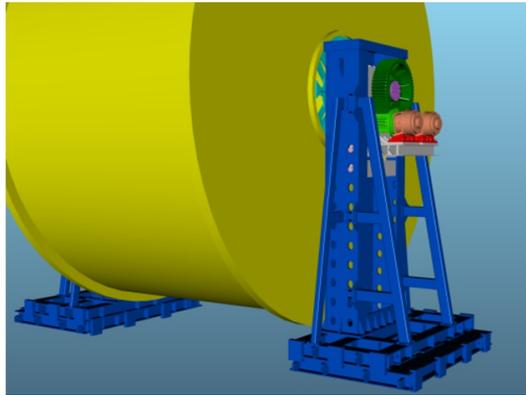
3 For a better understanding of the overall structure of the RDU, I have also attached below a

colour schematic diagram of the RDU.

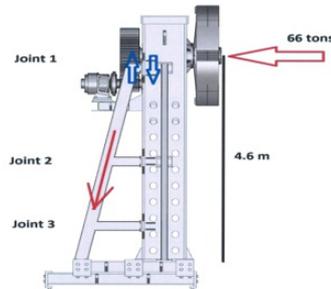
These struts are vital for the structure. If they slip, the bolts will come loose because of the slippage. Besides, the paint would be disintegrated because of the movement underneath the bolt and within the joint interface, leading to the structural integrity of the unit being jeopardised.

The slippage you are talking about, is it joint 1, joint 3 or joint 2?

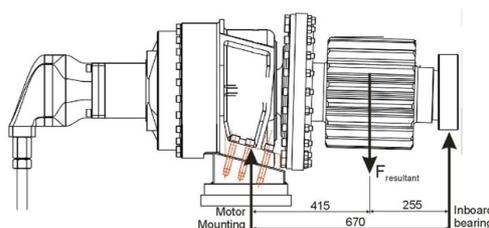
75 The pinion is connected to the output flange of the Sauer Danfoss gearbox by a series of bolts. The gearbox is itself located on a motor mounting as follows:

76 The Defendant submits that the Sauer Danfoss gearbox mounting was not under-designed because the Defendant had followed the manufacturer's specification by using three M20 bolts of a higher grade 12.9 on each side of the mounting and by tightening them to the specified torque of 540 Nm. However, no records were produced to support the Defendant's assertion that these bolts were in fact tightened to the torque of 540 Nm at the time of manufacture or testing prior to the delivery of the RDU to the Plaintiff.

79 Dr Eccles explained in his AEIC why the bolts at the Sauer Danfoss gearbox mountings were under-designed. Considering the maximum working design tension of 15 tonnes for the umbilical, the shear force generated is enormous and far exceeds the capacity of those bolts to restrain and the joint would slip. Slippage, even by fractions of a millimetre, would be sufficient to loosen the bolts, induce fatigue loading and reduce its operating life.

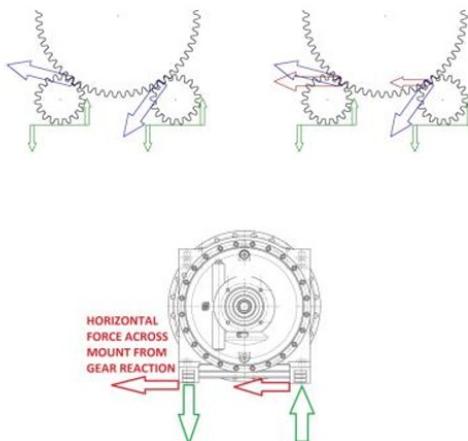
Vertical Forces from torque only in the case of the Cement Mixer

Additional Horizontal Force across the mount from the gear reaction in the case of the RDU

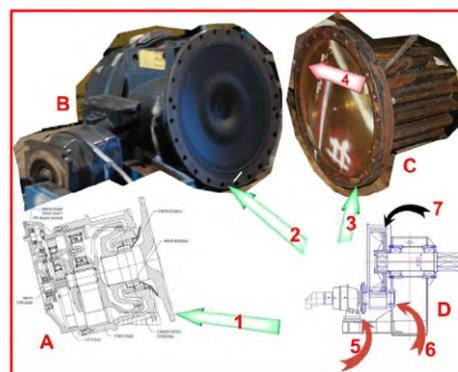
Figure 4 - Drive Unit to Final Pinion Assembly and Pinion Mounting

82 I turn next to consider the evidence of Mr Drago that the design of the interface between the Sauer Danfoss gearbox and the pinion was defective. As can be seen in the diagram below "Figure 4 – Drive Unit to Final Pinion Assembly and Pinion Mounting" reproduced from the AEIC of Mr Drago, the final drive pinion flange "Arrow 3" on the pinion gear "C" is mounted to the output flange "Arrow 2" of the Sauer Danfoss gearbox "B" by a series of bolts.

allocable pitch diameter runout of the gear set thus the effective alignment of the gear set will be severely compromised. **This condition will be very detrimental to the load capacity and life of the final drive pinion – gear set. This is a very serious gear system design error.**

86 I agree with the conclusion of Dr Eccles and Mr Drago that as a result of the potential movement arising from the 0.2 mm clearance at the spigot, the potential misalignment in concentricity at the interface between the Sauer Danfoss gearbox and the pinion flanges is unacceptably large for the bolts and the gears. After considering the totality of the evidence of the experts, I find that the bolting arrangements on the mounting of the Sauer Danfoss gearbox and the pinion/gearbox flange interface were both inadequately designed.

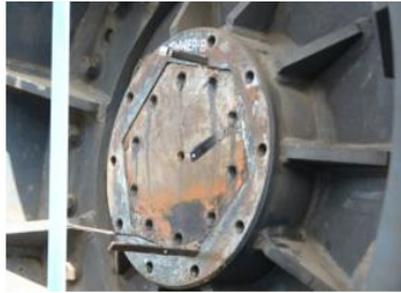
Gear side of Tower B

87 The shaft end plates provide attachment of both the main gear and the hub drive insert to the main driveshaft between the gear and the reel hub. Ten M20 x 55 mm, grade 8.8 bolts attach the plate to the hub/gear, with a further ten bolts of the same specification attaching the same plate to the shaft.

88 Dr Eccles explained in his AEIC from pp 9 to 33 why the bolting arrangements on the shaft end plates were inadequate. At the hot-tubbing, Dr Eccles calculated that if the brakes were applied to slow down the 300 tons reel spinning at 0.29 rpm, corresponding to a lay speed of 500 m per hour, it would cause the bolts at the drive shaft end plates to be overloaded. With the clearances present, measuring about 1.3mm to a maximum of 2.5mm, between the hexagonal shaft and the gear on the one end and the reel insert on the other, the bolts would come loose. Mr Hooper disagreed with Dr Eccles and asserted that the hexagon in the hexagonal shaft took the shear load/torque transmission and not the bolts which merely held the gear hub in place. However, the hexagonal shaft would be able to take the shear load only if the clearances were absent and the hexagon fitted tightly within the hub. Mr Hooper then speculated that *"it may have been that on the end of the hexagon, there was a slight taper put on in order to get the hub to fit on..."*, which then took up all the clearance on the hexagonal section.

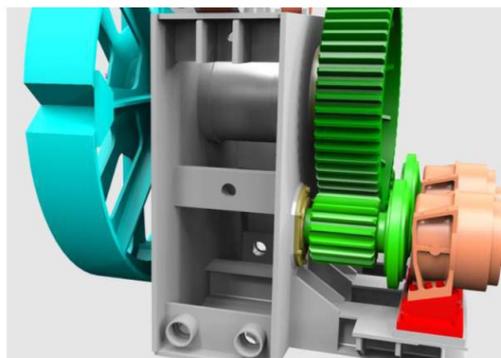
115 Mr Moore examined the fabricated sub-frame structure of the RDU that housed the bearings for the pinion gears, the main gear and the drive shaft and opined that they were inappropriately designed. Accordingly to Mr Moore, the relatively thin braces and the I-section beams within the structure provided little in the way of stiffening and torsional stability. The CAD model below shows the internal construction:

116 Mr Moore noted that the RDU's bearing housings were being supported and located by the bolts. In his view, heavy-duty fabricated structures are normally used to support such a drivetrain. The bearing housing is usually designed to be an integral part of the fabrication. This negates the need to rely on the bolts to attach the bearing housing to the main fabrication. In such cases, the item would be designed and manufactured as a casting or heavy-walled fabrication and would also incorporate strengthening members as part of its design. This ensures sufficient local rigidity and support of the loading experienced by the pinion bearing and provides a means of load transfer into the sub-frame fabrication which in turn transfers its load into the main support towers. Further, the bearing is normally located directly into the heavy walled structure via a very tight clearance fit. This

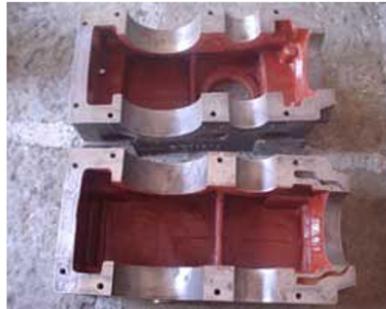
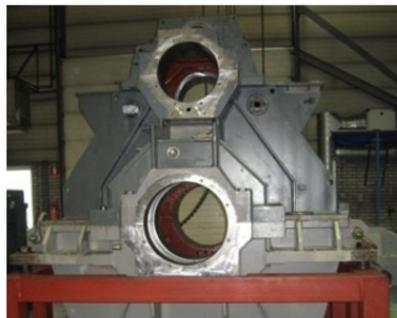
provides a rigid base to seat and support the bearings whilst under load and provides an accurate machined datum, consequently giving better alignment of the bearing to the outboard mounting of the pinion. A similar arrangement is also appropriate for the bearing housing for the main driveshaft. This is critical to ensure correct alignment of the pinion gear to the spur gear. A similar arrangement appropriate for the bearing housing for the main driveshaft is also critical to ensure correct alignment of the pinion gear to the spur gear. In his report, he showed the following examples of correctly designed bearing and gearbox housings.

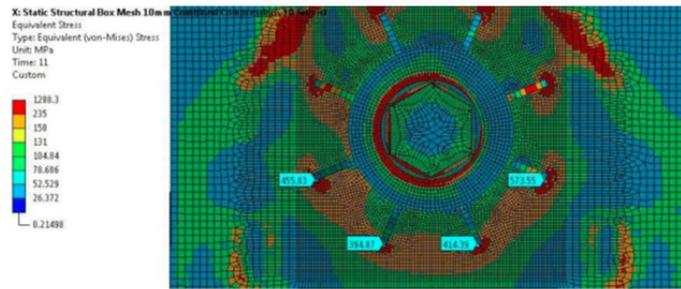
Figure 3 – Von Mises Stress with the Compression and Transverse Load from the Reel

Figure 2 and Figure 3 above describe the stresses when the towers are snug to the reel and when one of the tower is subject to the compression plus transverse loads. Due to the compression load from the reel on the tower, the effect of the transverse load is intensified when both compression and transverse loads acting in the same direction. During this phase, the von Mises stress becomes worse as tabulated in the Table 1 below.

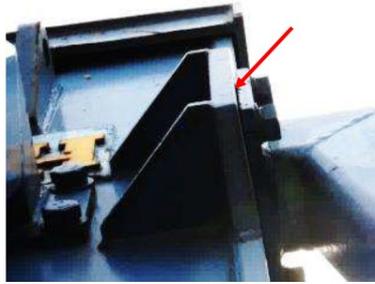
172 The Nobletech Report established the existence of gaps in the flange plates of the struts that were attached to different parts of the tower frame. Some of these gaps were significant (See 6 AB 5088). Mr Moore opined that these gaps were likely to be the result of poor joint design and the bolts loosening during the last operation and he added that:

It is essential that any joints such as this do not have a gap between the components. Working faces must be in contact and have the correct pre-load applied; otherwise friction between the two components will be non-existent. This will lead to gaps, joint slip and transfer of loading to the bolts which will ultimately fail by shear or fatigue.

173 Given the results of Dr Eccles's analysis predicting loosening of the bolts on these joints due to cyclical loading, I am inclined to accept the Plaintiff's experts' conclusion that these gaps probably formed as a result of the bolts loosening during the RDU's operation.

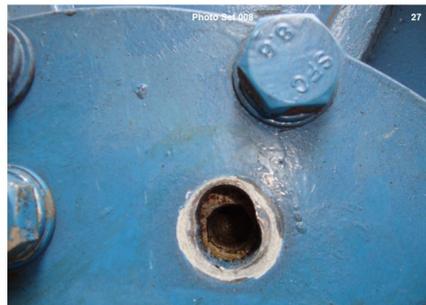
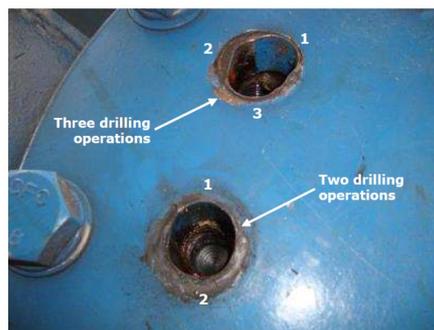
174 From the photographic evidence, it is clear to me that the bolt clearance holes in the sub-frame end plate were badly drilled evidencing poor manufacturing practices. It would appear that there were machining errors with misalignment in the original hole pattern and re-drilling had to be done at the component fit up stage so that the bolts could be screwed into the threaded holes. Mr Philip Chua confirmed that the pre-drilling was done in China. During the assembly of the parts in Singapore, re-drilling was done if the bolts could not match the clearance holes.

Figure 53: Elongation of holes due to initial incorrect positioning

175 The Plaintiff submits that the re-drilling modifications would exacerbate movement of the component, especially when combined with insufficient bolt pre-loading and would not be acceptable especially for a component that was critical to ensure the secure attachment of critical gear drive components. I agree.
