Smile Inc Dental Surgeons Pte Ltd v OP3 International Pte Ltd  
[2017] SGHC 246

**Case Number** : Suit No 498 of 2015  
**Decision Date** : 05 October 2017  
**Tribunal/Court** : High Court  
**Coram** : Chan Seng Onn J  
**Counsel Name(s)** : Ho Chien Mien and Ng Chee Jian (Allen & Gledhill LLP) for the plaintiff; Vijai Dharamdas Parwani and Nicholas Winarta Chandra (Parwani Law LLC) for the defendant.  
**Parties** : Smile Inc Dental Surgeons Pte Ltd — OP3 International Pte Ltd

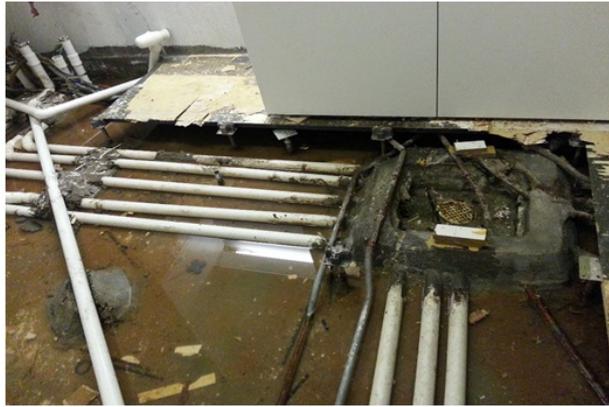
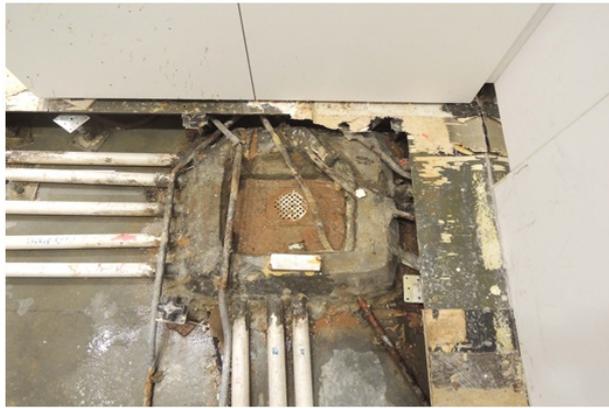
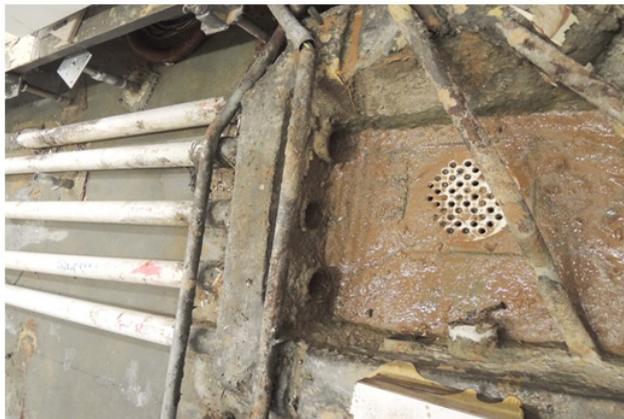
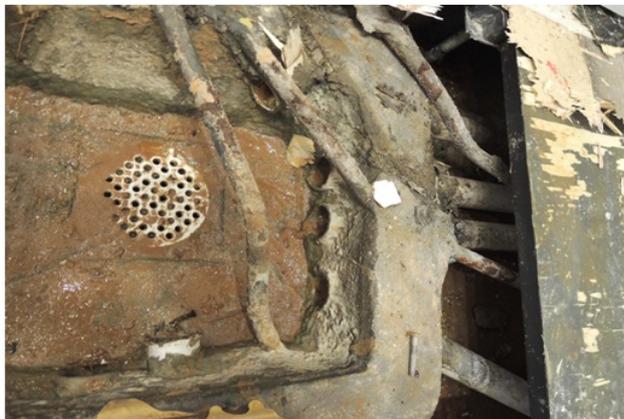
### **Annex A**

(b) The drainage downpipe for water to be discharged out of the Suntec Clinic (the "Drainage Downpipe") was situated in a raised bunded area (the "Bunded Area"). The Suntec Clinic produced debris, which clogged up the white circular plastic floor grating (the "Floor Grating") that covered the Drainage Downpipe. This caused water to overflow the Bunded Area. (The Bunded Area is 340mm in length and 300mm in breadth, and is enclosed by a bunded concrete wall 65mm in thickness and 100mm in height. The photographs in Annex A to this judgment show the Bunded Area.)

107 For the reasons stated above, I agree with the plaintiff's submission that terminating the nine discharge pipes *above* the Floor Grating, and at the raised Bunded Area, was a serious design flaw, which was the primary cause of the 1st and 2nd Floods. I find that no reasonable contractor would have provided for such a drainage system, which Dr Liew likened to a "death certificate signed" for flooding to occur. [\[note: 63\]](#)

111 For all these reasons, I accept the plaintiff's submission that the flooding was primarily caused by (a) the termination of the outlets of all nine discharge pipes above the Floor Grating; and (b) the presence of the bunded walls, which prevented water outside the Bunded Area from draining into the Drainage Downpipe.

115 Further, Dr Liew also observed that, on the whole, the construction was shoddy. The walls and floor of the Bunded Area should at least have been tiled for hygiene purposes, instead of being left with rough unfinished cement surfaces. Tiling up the Bunded Area would have helped to prevent mould growth and would not have been very costly.

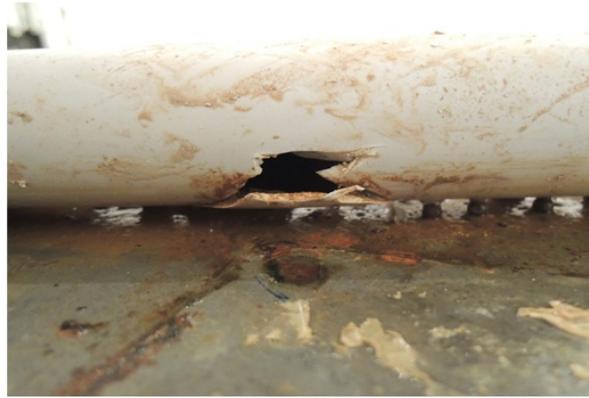
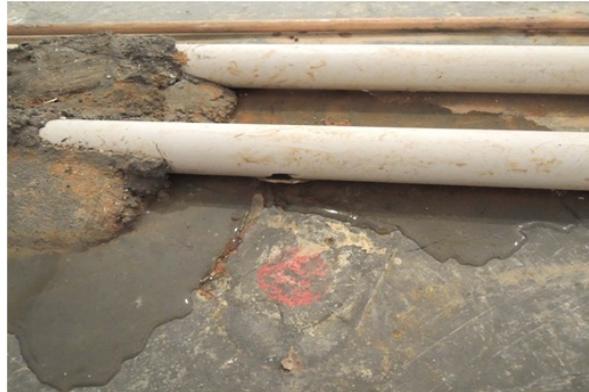
- (a) leakage of water through the hole (see the photographs attached in Annex B to this judgment) in the waste water discharge pipe (the "Drainage Pipe") from the dental chair in Surgery Room No 3 of the Suntec Clinic;
- (b) the design and installation of nine discharge pipes (the "discharge pipes") whose discharge outlets were situated above the Floor Grating (see the photographs in Annex A to this judgment); and
- (c) the design and construction of the raised bunds, which prevented water that had overflowed the Bunded Area from draining into the Drainage Downpipe.

48 For the following reasons, I do not accept the plaintiff's allegation, set out in [46(a)] above, that the repeated flooding was caused by damage to the Drainage Pipe (attributable to the defendant). I find that the defendant did not damage the Drainage Pipe.

51 I therefore find that the water leakage test performed using the hydrostatic test method, which were conducted *prior to* the removal of the floor boards after the 2<sup>nd</sup> Flood, eliminates the possibility that there was a hole or puncture in the Drainage Pipe when the defendant *first* handed over the Suntec Clinic to the plaintiff. The Drainage Pipe, as shown in the photographs at Annex B, was thus not damaged by the defendant during its installation of the raised platform for the floor. I conclude that the Drainage Pipe must have been damaged during the removal of the pedestals and the raised floor platform *after* the 2<sup>nd</sup> Flood, by the plaintiff's own contractors. The flooding was accordingly not caused by leakage of waste water through the hole in the Drainage Pipe, as postulated by the plaintiff.
