**IN THE COURT OF APPEAL OF THE REPUBLIC OF SINGAPORE**

**[2023] SGCA 20**

Court of Appeal / Civil Appeal No 45 of 2022

## JUDGMENT

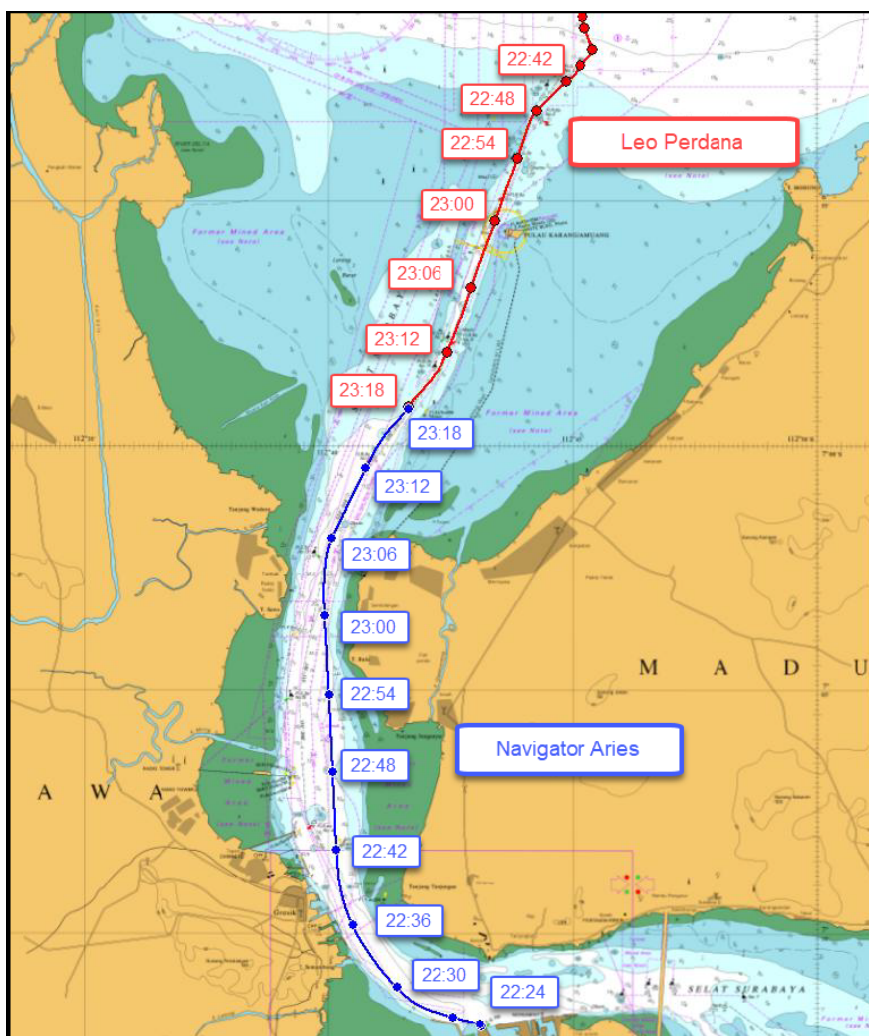
14 The vessels were thus on reciprocal courses within the Strait. This is illustrated in the following plot prepared by the respondent’s experts, which shows the actual track taken by each vessel (with timestamps reflecting local time):

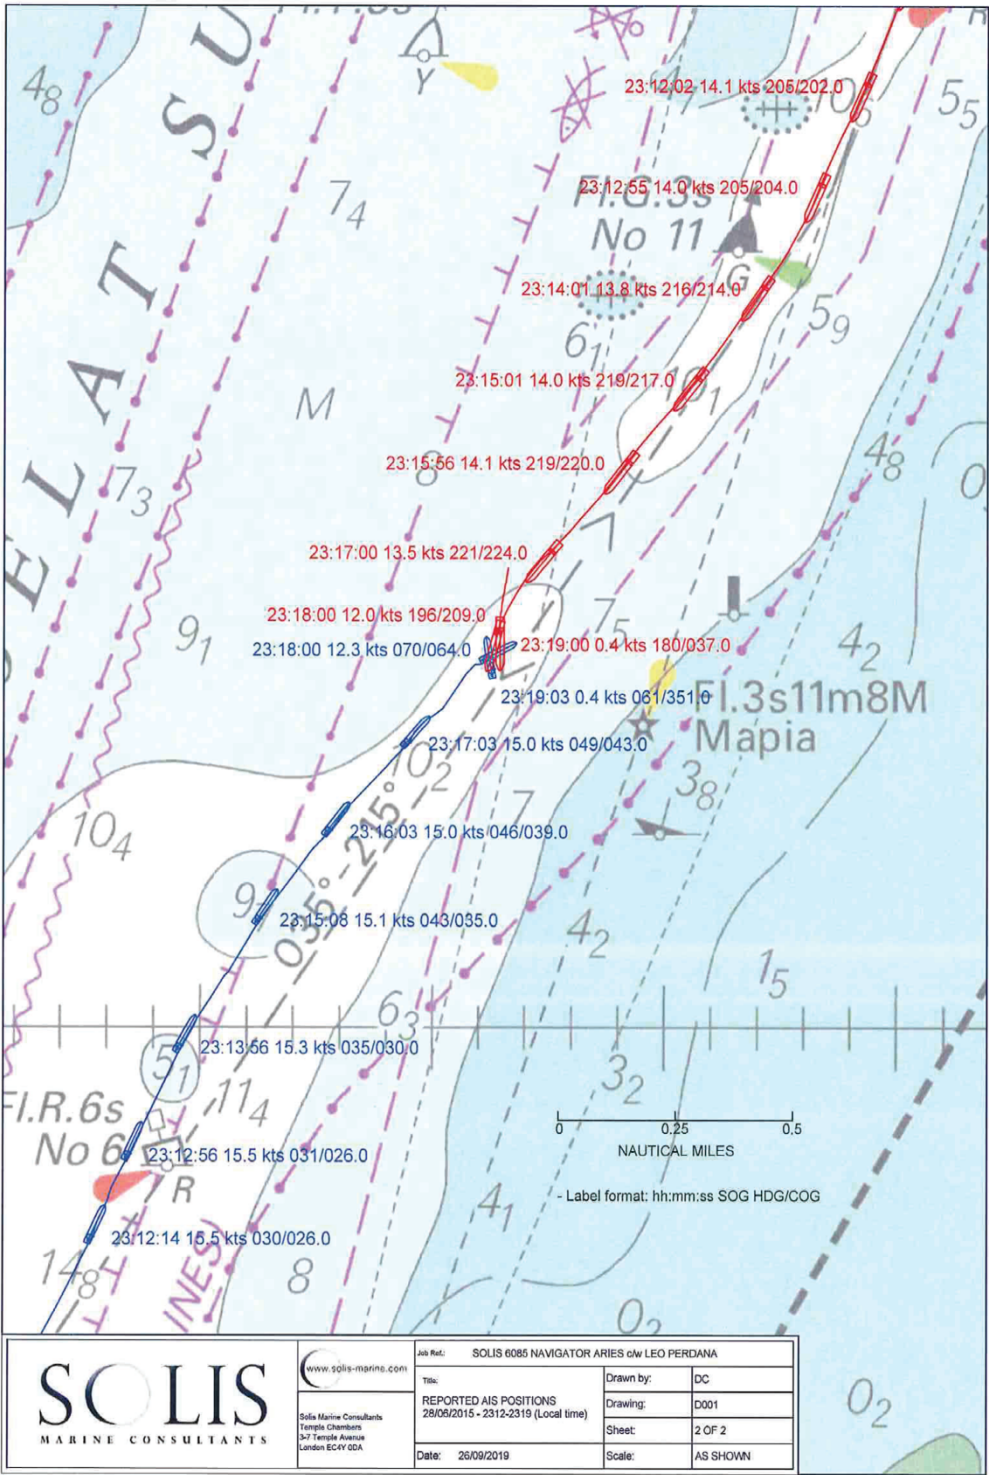
15 The period of the voyage starting from 23:12 hours is most relevant to the collision. The vessels’ tracks for this period have been mapped out by the appellant’s experts using the vessels’ automatic identification system (“AIS”) data (with the AIS heading data generated from each vessel’s gyro compass):

32 The collision occurred at 23:17:51 hours, to the west of the Recommended Track (see the diagram at [15] above).

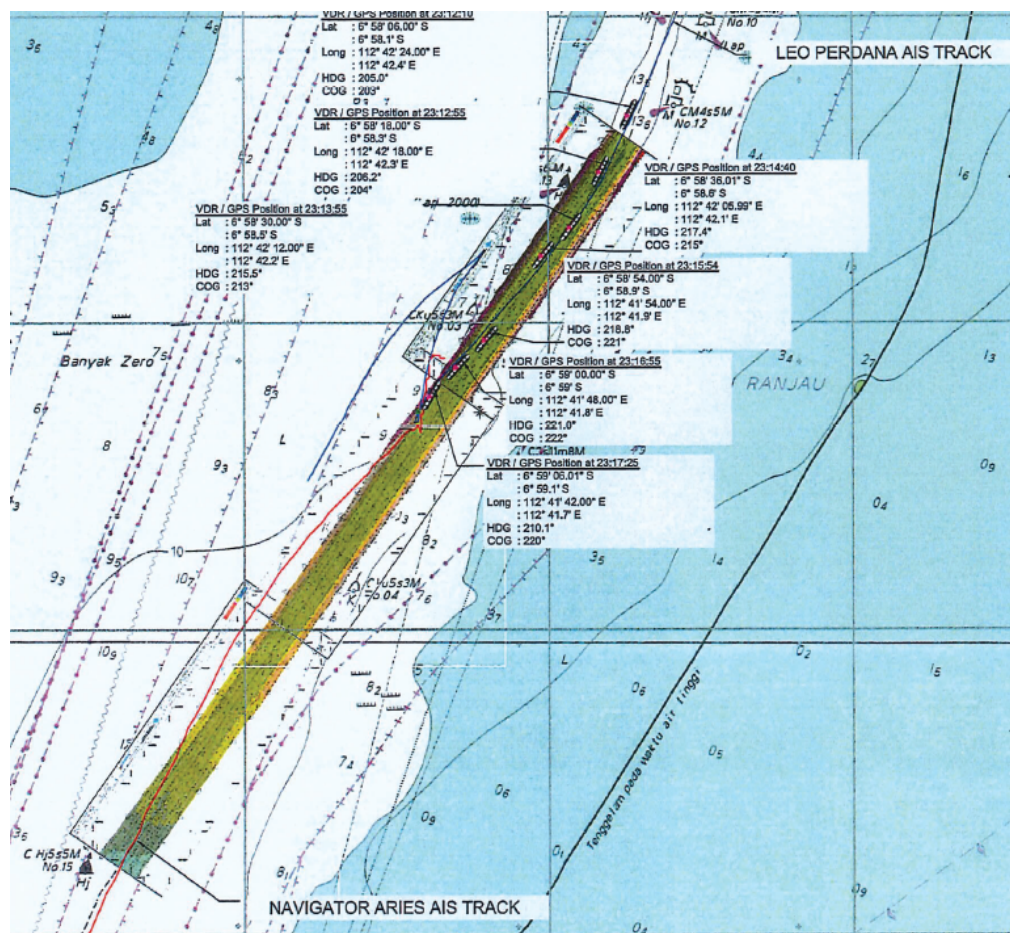
20 Within the buoyed channel was a dredged channel (the “Dredged Channel”). Dredging works took place from 2014 to May 2015, to deepen part of the buoyed channel from 9.5m to up to 13m (chart datum), and to widen the width of this dredged section from 100m to 150m (this distance excludes slopes extending outwards on either side of the Dredged Channel). This is the section that appears mainly in green in the following overlaid chart:

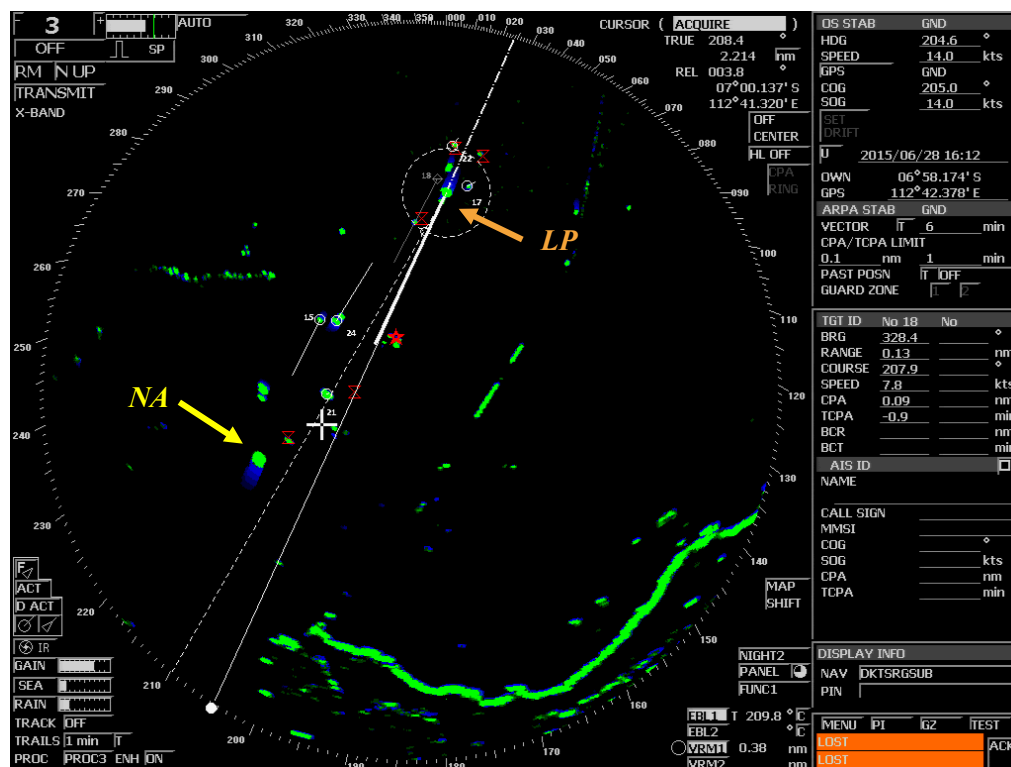
26 At this stage, each vessel was on the port side of the other’s course over ground (“COG”) line. This is illustrated partly by the following screengrab from the *LP*’s X-Band radar taken at 23:12:21 hours. To give effect to the port-to-port passing agreement, it would have been clear that both vessels needed to make course alterations to starboard.

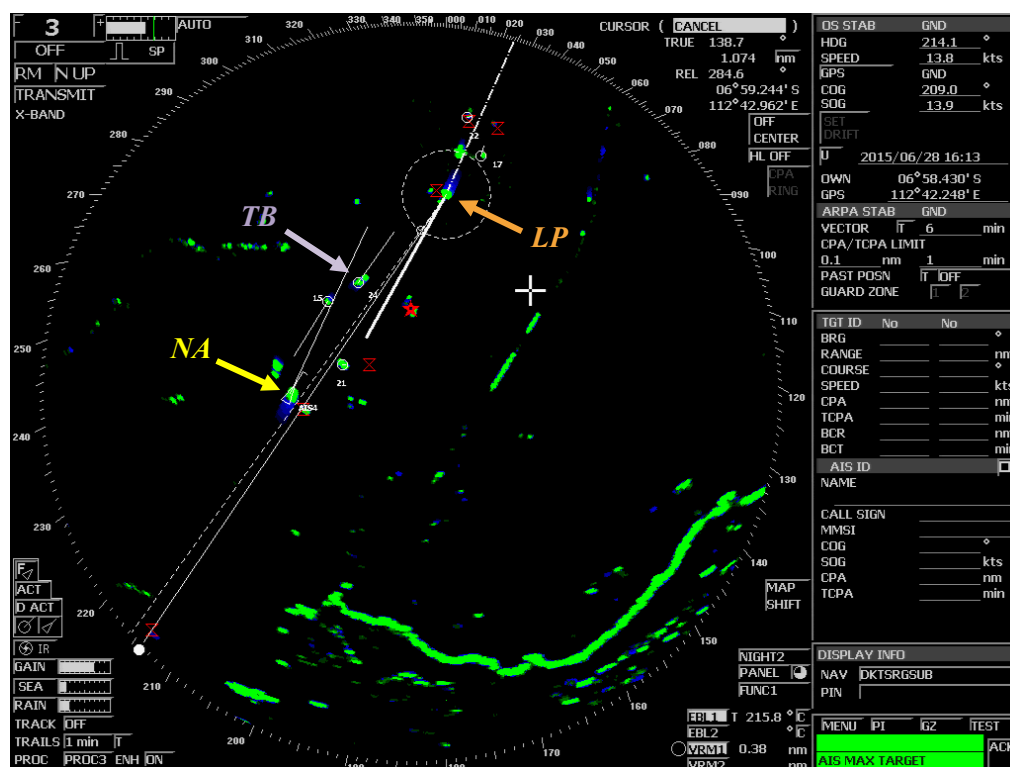
31 The following screengrab from the *LP*’s X-Band radar, taken at 23:13:36 hours, reflects the relative positions of the vessels when the starboard-to-starboard passing agreement was reached with the *TB*:
